INDAGINI AMBIENTALI
DEL SITO

Environmental Due Diligence

Tower plot
Via Reiss Romoli, Settimo Milanese (MI)

Revision:	00
Date:	02/12/2020
Project n.:	2206187
Prepared for:

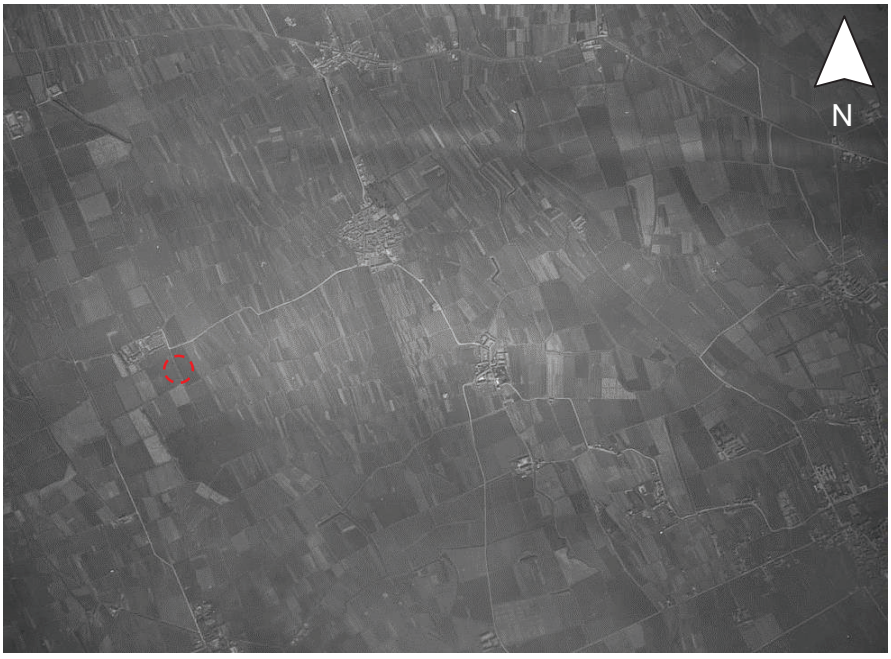
#	Date	Source
1	1951	Geographic Military Institute

The Site appears to be an agricultural land.
No further information is available due to the low resolution of the photo.

Surrounding areas to the east, west and south appears to be agricultural lands, while the area located to the northwest is characterised by the presence of buildings.
No further information is available due to the low resolution of the photo.

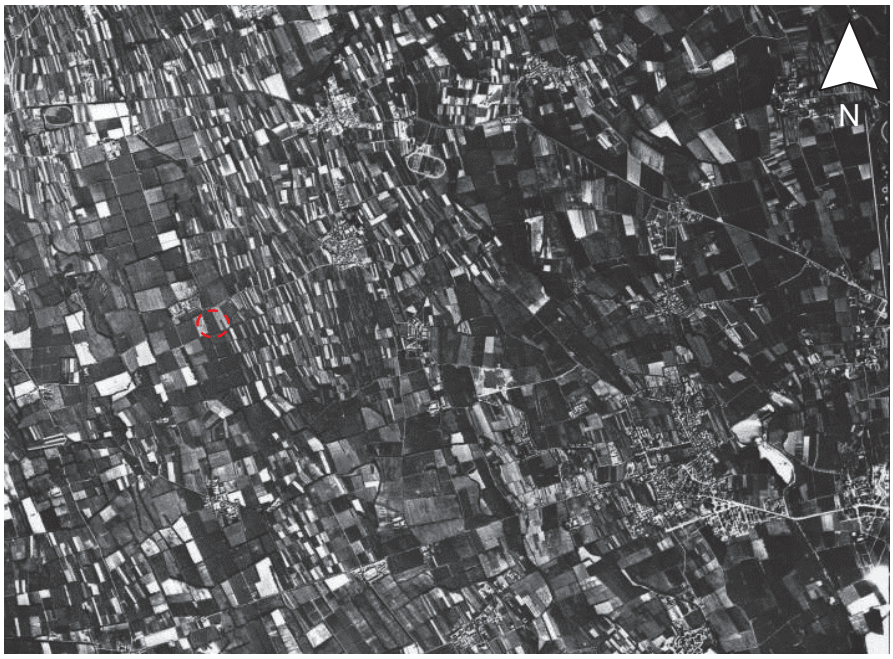
#	Date	Source
2	1955	Geographic Military Institute

No significant changes in the Site layout.
No further information is available due to the low resolution of the photo.

No significant changes in the surrounding areas.
No further information is available due to the low resolution of the photo.

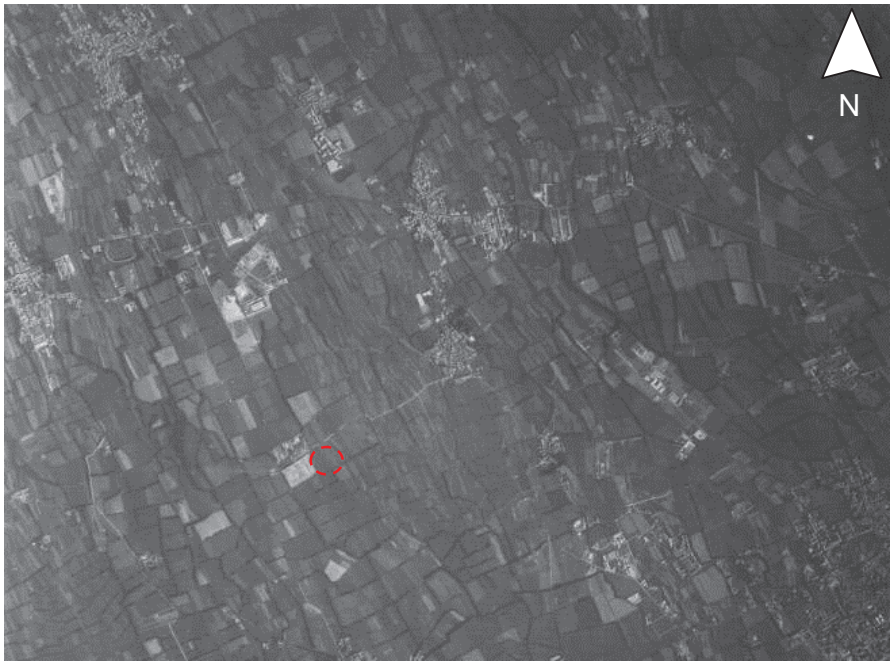
#	Date	Source
3	1962	Geographic Military Institute

No significant changes in the Site layout.
No further information is available due to the low resolution of the photo.

Earthmoving activities are visible adjacent to the western boundary of the Site.
No further information is available due to the low resolution of the photo.

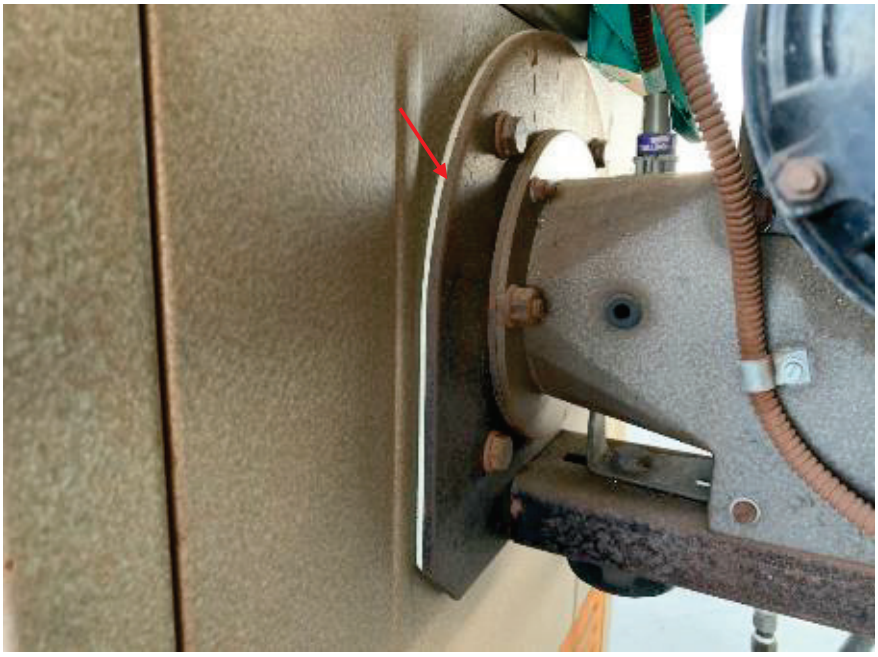
#	Date	Location
17	28.10.2020	Tower Plot - Inside area

ACMs risk	Based on the information reported in this report, the risk associated with the potential presence of ACMs is to be considered high.
Man-Made Vitreous Fibers	Based on the available documentation and the information provided by the landlord representative, no Man-made Mineral Fibers (MMVFs) survey was ever conducted on Site. During the Site inspection, no MMVFs were observed on Site. Nevertheless, potential MMVFs could be present in correspondence of the insulation of pipes, ducts and air heaters located in the water tower.
MMVFs risk	Based on the information reported in this report, the risk associated with the potential presence of MMVFs is to be considered moderate.

Presence of potential ACMs: gaskets located in correspondence of the two air heaters
